## Water management at Deccan international school (Total area: 10 acres) - situated in a low-lying area near the dry Chikka Kalasandra lake

Water demand: 35 KL/day; rainwater harvesting potential: 13801 KL/annum

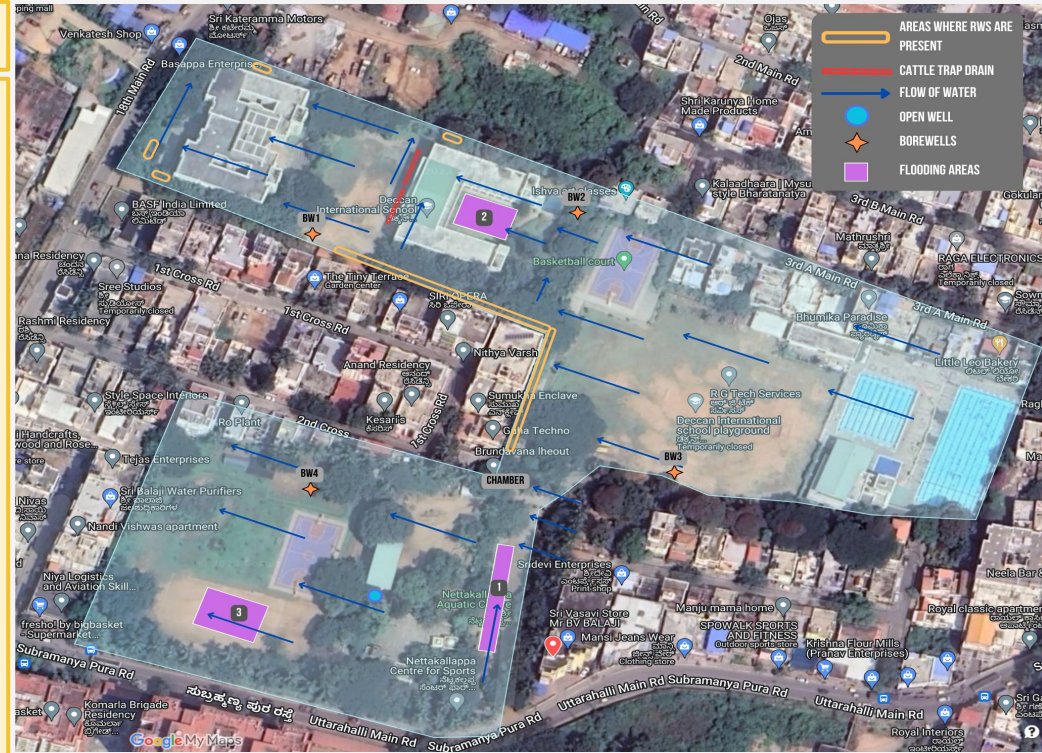
- Flooding during heavy rains - concentrated in 3 areas:
  - Flooding area 1 - Parking lot
  - Flooding area 2 - Junior school courtyard
  - Flooding area 3- Open area behind Ashram school
- Water scarcity during summer, hence major dependence on tankers (~12 KL of tanker water/day)
- Lack of filtration to the direct borewell recharge in one borewell led to its siltation rendering it unusable
- Harvested rainwater from the junior school block passes through the muddy courtyard and then into the rainwater tank leading to heavy silt accumulation in the tank, so this water is not used

- Remedying siltation in borewell with direct recharge with the help of a filtration system and recharge wells
- Flooding area 1 (slope: towards the school with a catchment beyond the school): 2 consecutive recharge wells (5ft x 30ft) overflowing into a chamber that is connected to the main internal SWD of the school
- Flooding area 2 (runoff: 199 KL / annum): cattle trap installed downstream of the area to direct runoff into the main SWD; 11 recharge wells dug in main internal SWD
- Flooding area 3 (runoff at least 47 KL / annum): effect of intervention in the above two flooding areas has resulted in elimination of flooding in this area
