Rajiv Nagar Higher Primary School

Vijayapura, Karnataka

Intervention: Rainwater Harvesting with improvement in water and sanitation infrastructure

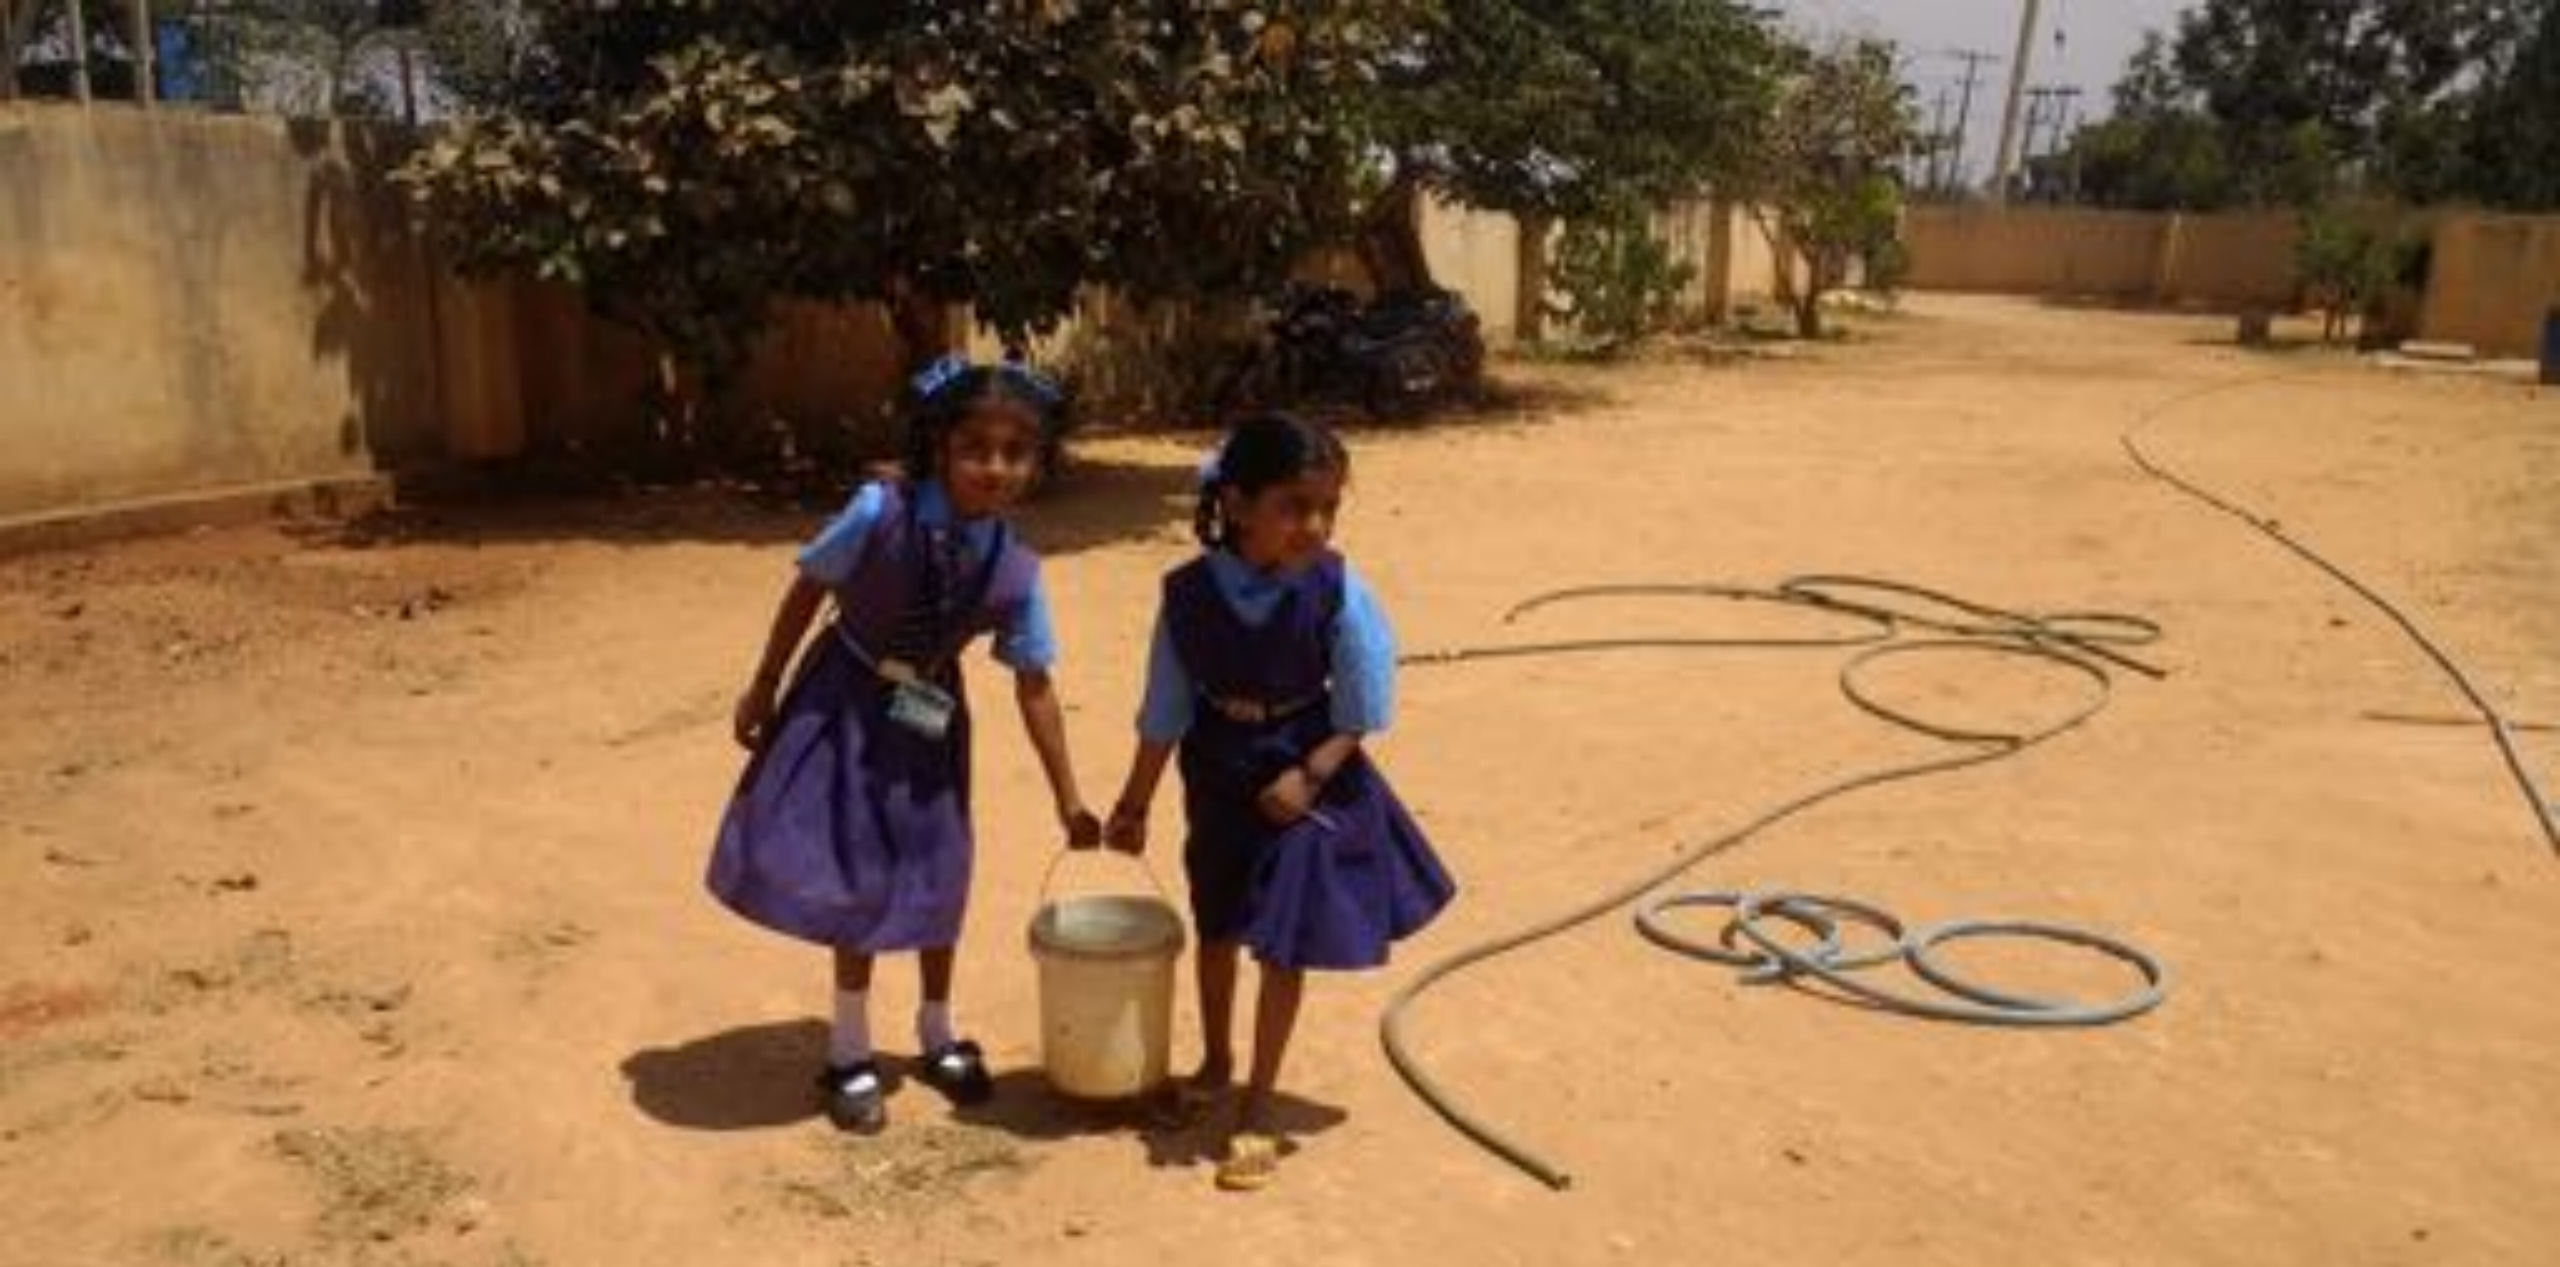
Water needed to be carried: Students carrying the water in buckets for toilets

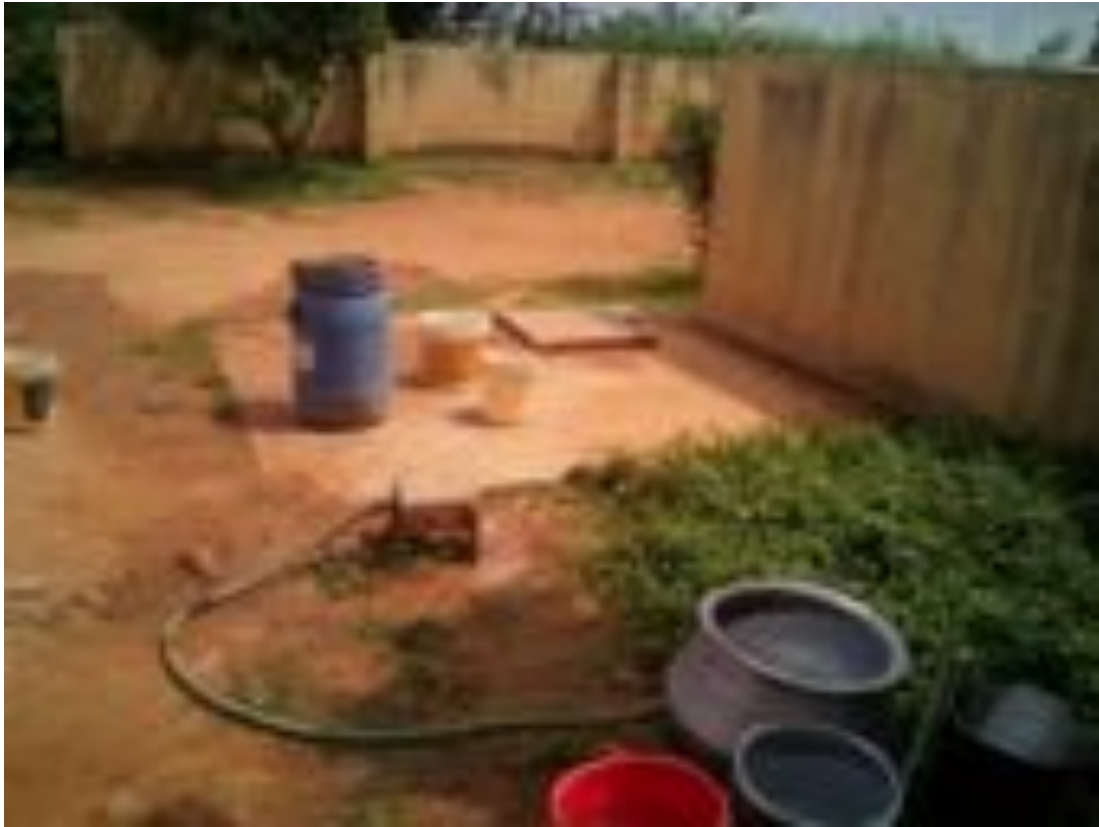
No provision of OHT, water needed to be stored in small storage containers

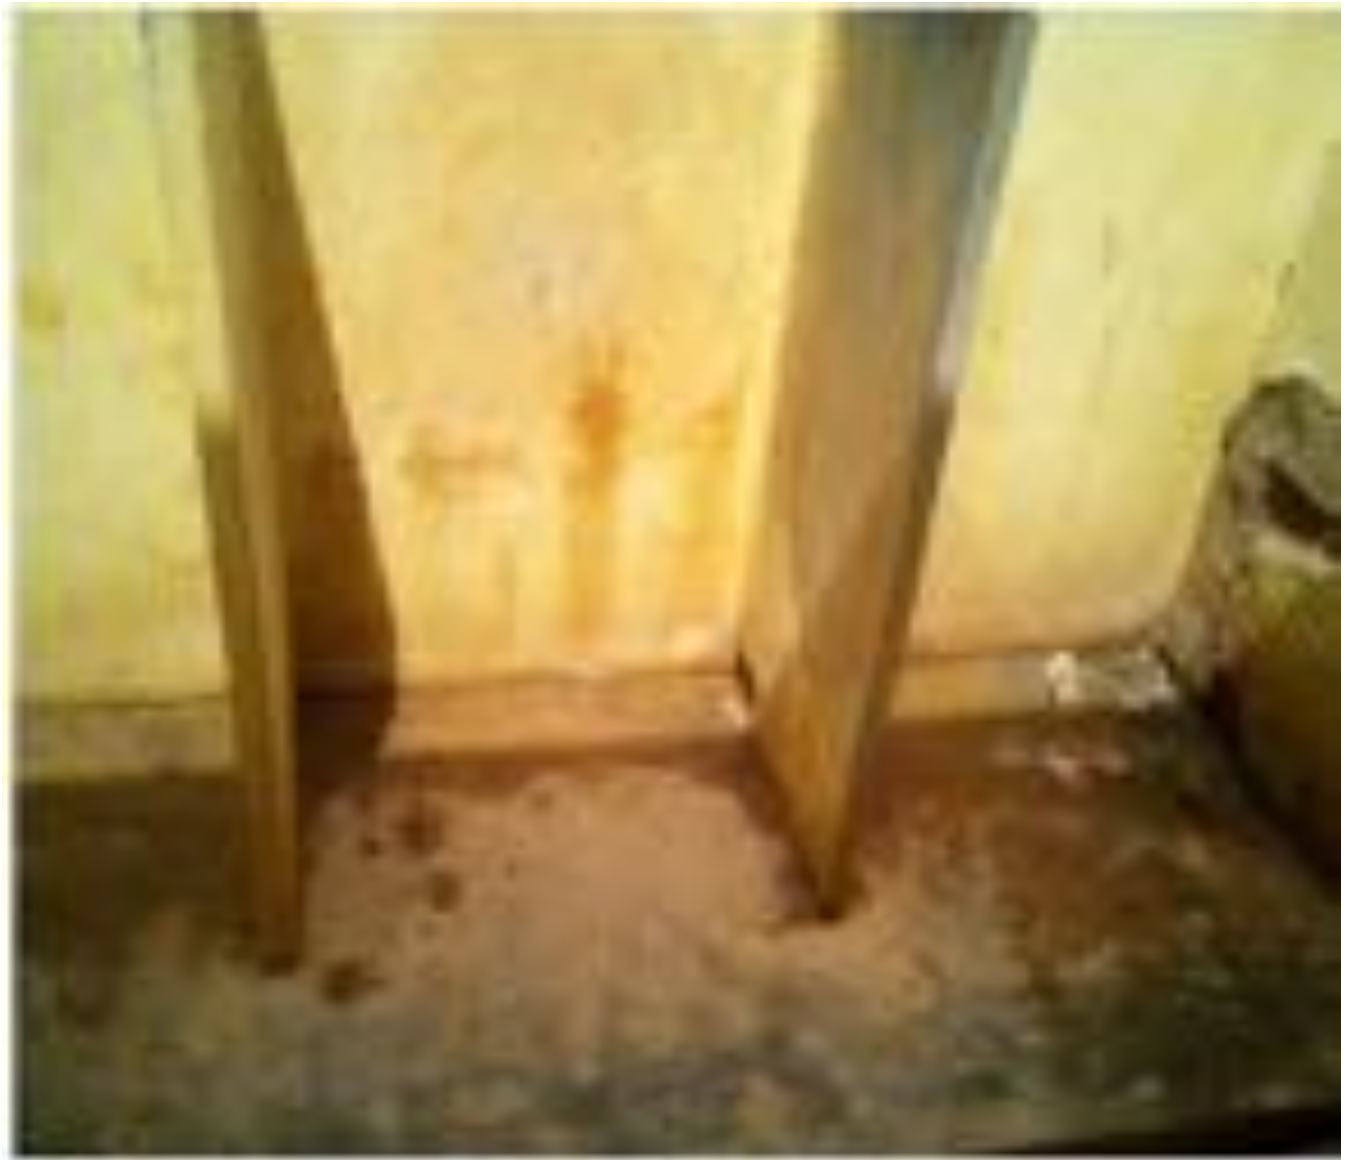
Urinals without appropriate drainage

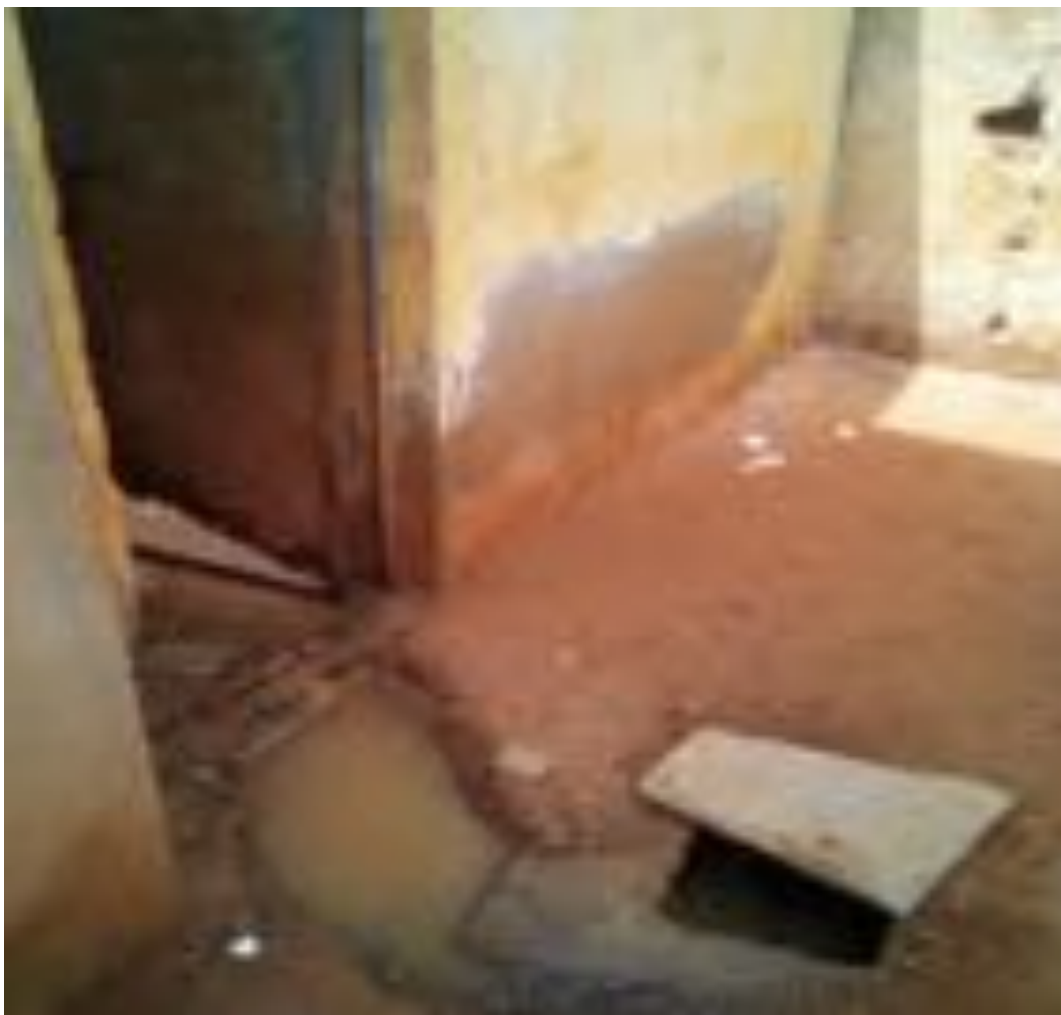
Water stagnation near toilet blocks, Broken toilet door

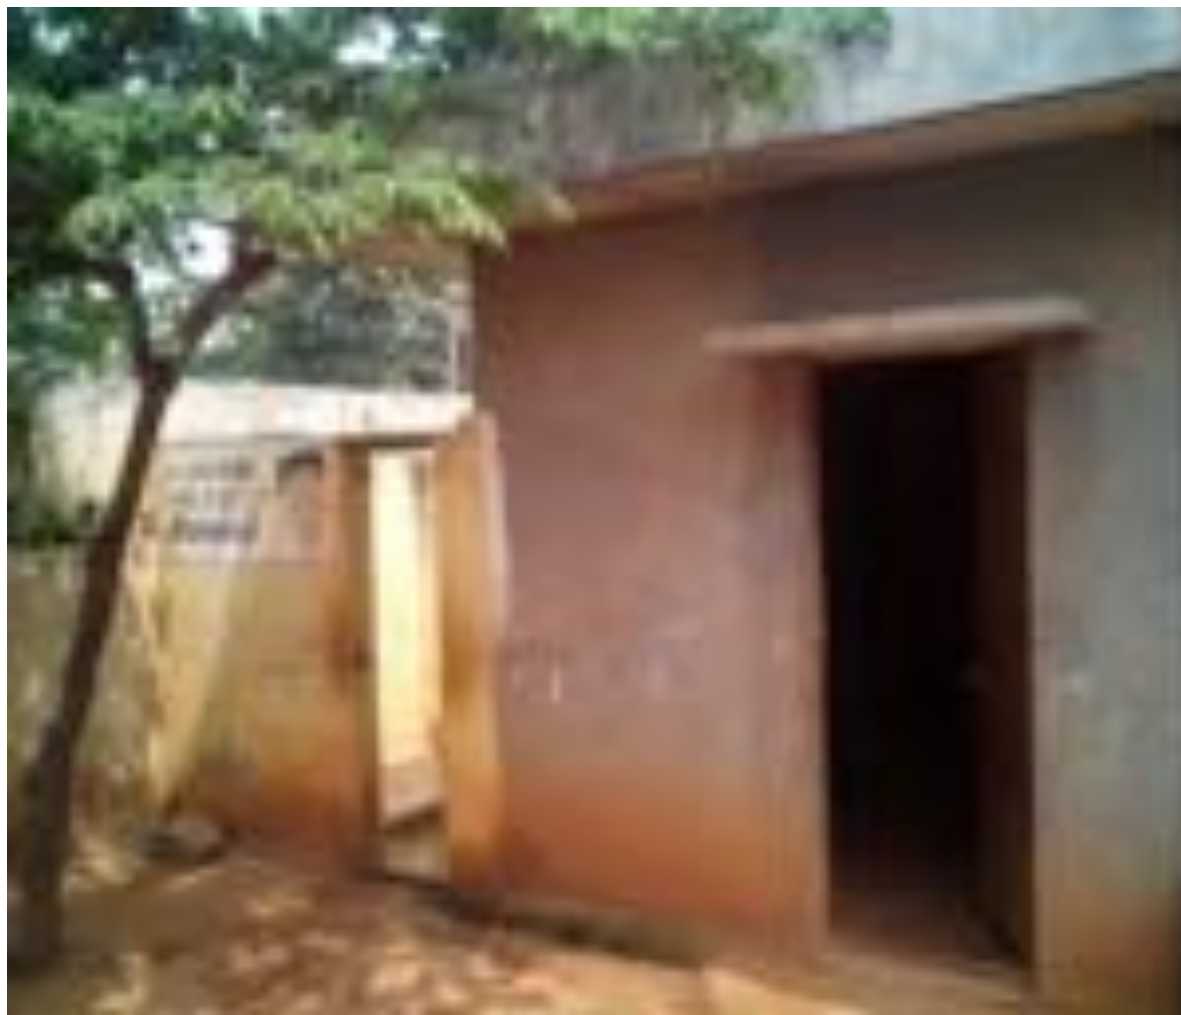
No plumbing to the toilets

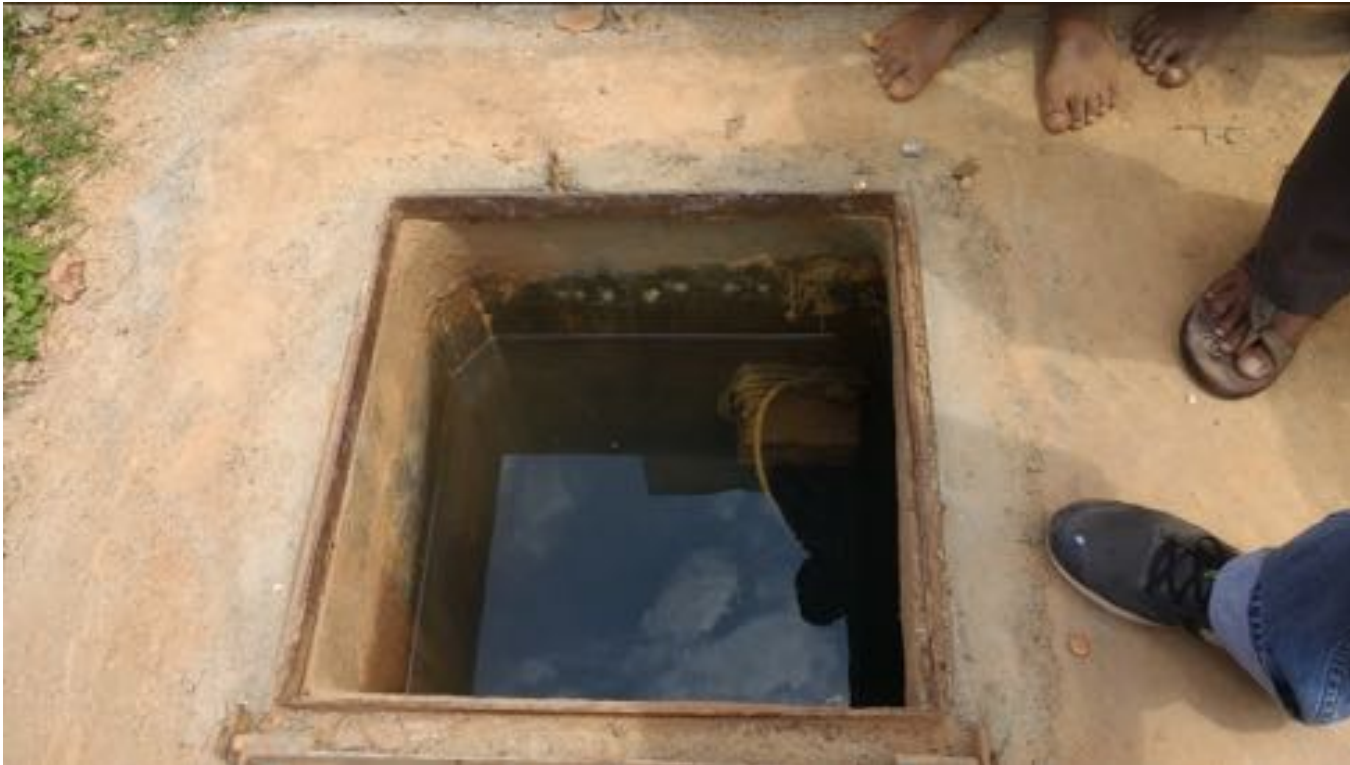
And it rained..the sump is full. The rainwater will be enough 2-3 days and even if the Panchayat supply doesn't come for 2-3 days, school children would not suffer.

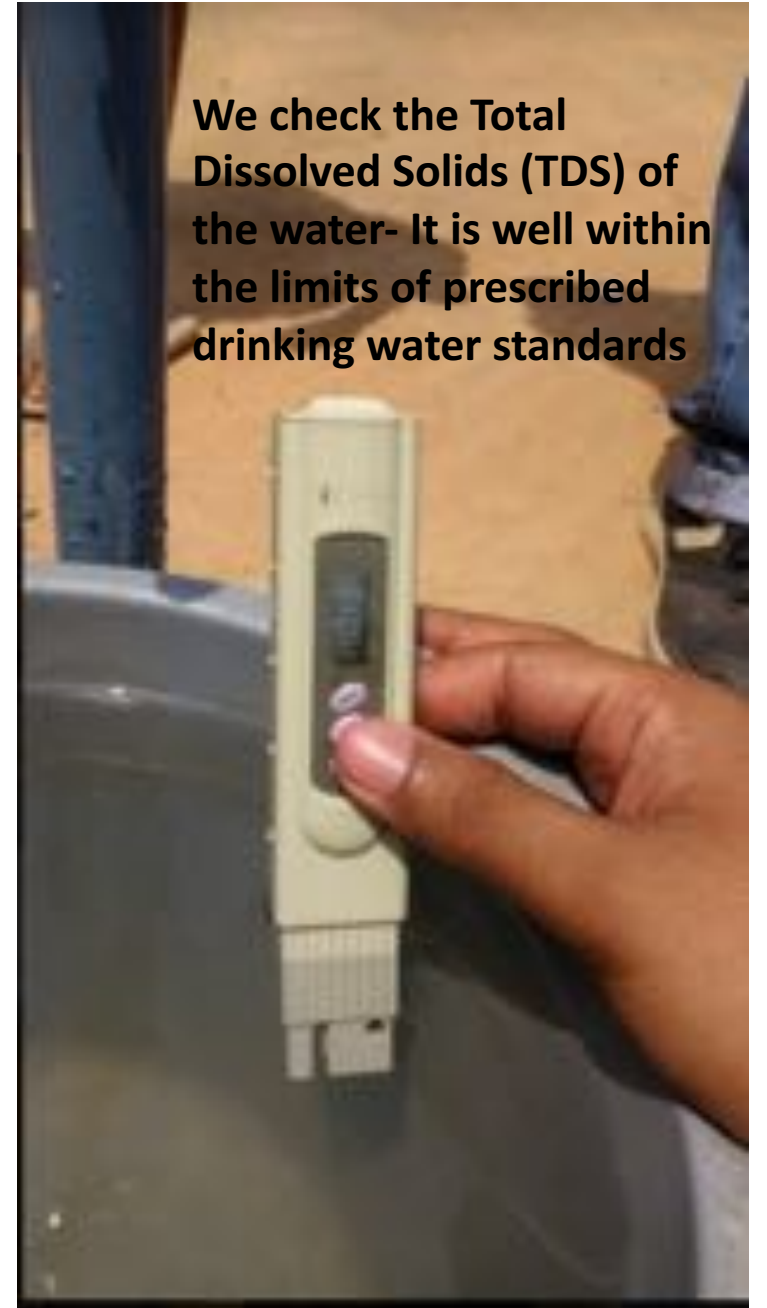
We check the Total Dissolved Solids (TDS) of the water- It is well within the limits of prescribed drinking water standards
